**District  
of Columbia  
Public  
Schools**

**Facilities Assessment**

**Langley Junior High  
#418**

**3DI/AEPA  
August 3, 1992**

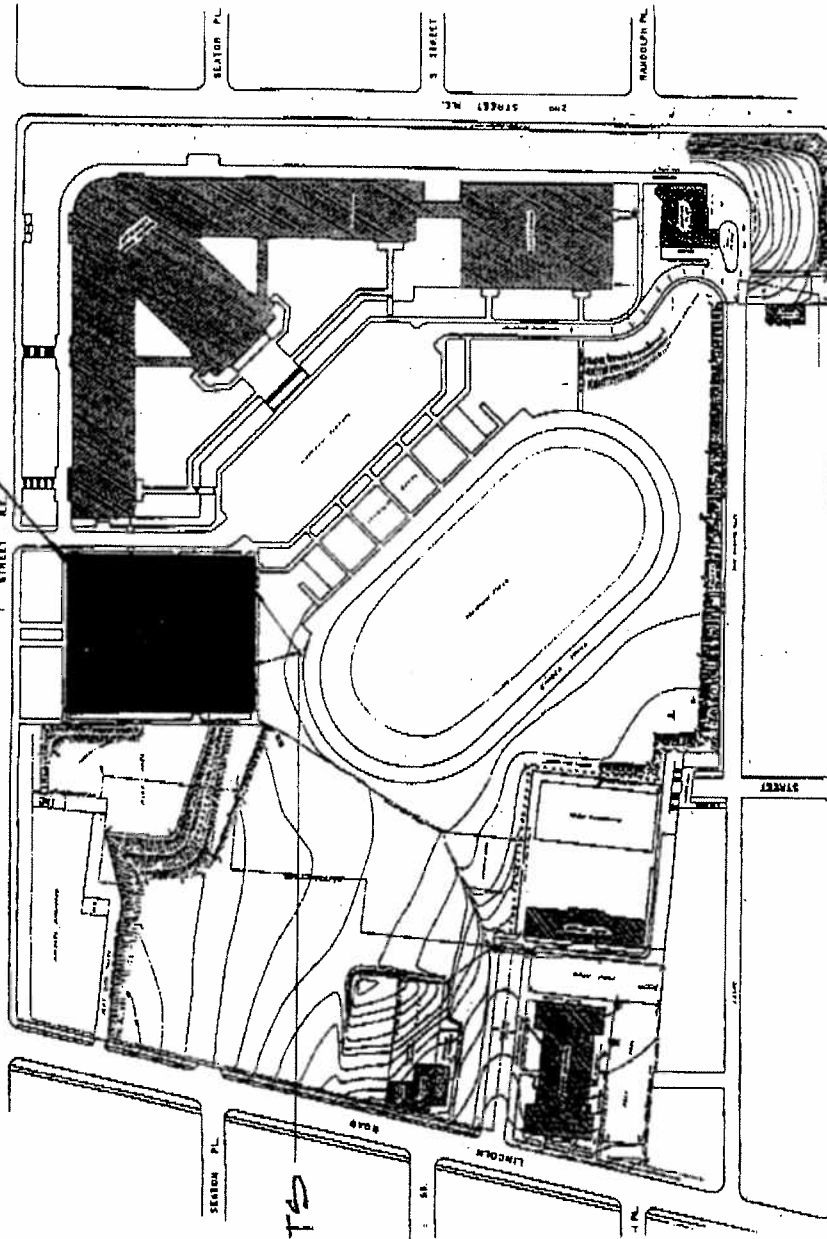
3DI/AEPA	Date 11/6/92	School No. 418/J.H.
DC Public Schools Facilities Assessment Survey	SITE PLAN	LANGLEY JR. HIGH SCHOOL

The school is located on T St., N.E. two blocks east of N. Capitol St., in a residential neighborhood. It is adjacent to McKinley H.S. The topography is flat with steep embankments on the south and east sides. The site has grassed areas in the front. The site has concrete walks. Drainage is adequate. The walks are in poor condition and need repair. We recommend paving of dirt paths to prevent erosion. The site is in generally good condition. Site lighting is provided by lights mounted on the building, 5 of these are broken and require replacement.

BROKEN LIGHTS
